STATE OF MARYLAND
BOARD OF NATURAL RESOURCES
DEPARTMENT OF GEOLOGY, MINES AND WATER RESOURCES
JOSEPH T. SINGEWALD, JR., *Director*

BULLETIN 6
SHORE EROSION
IN
TIDEWATER MARYLAND

1949

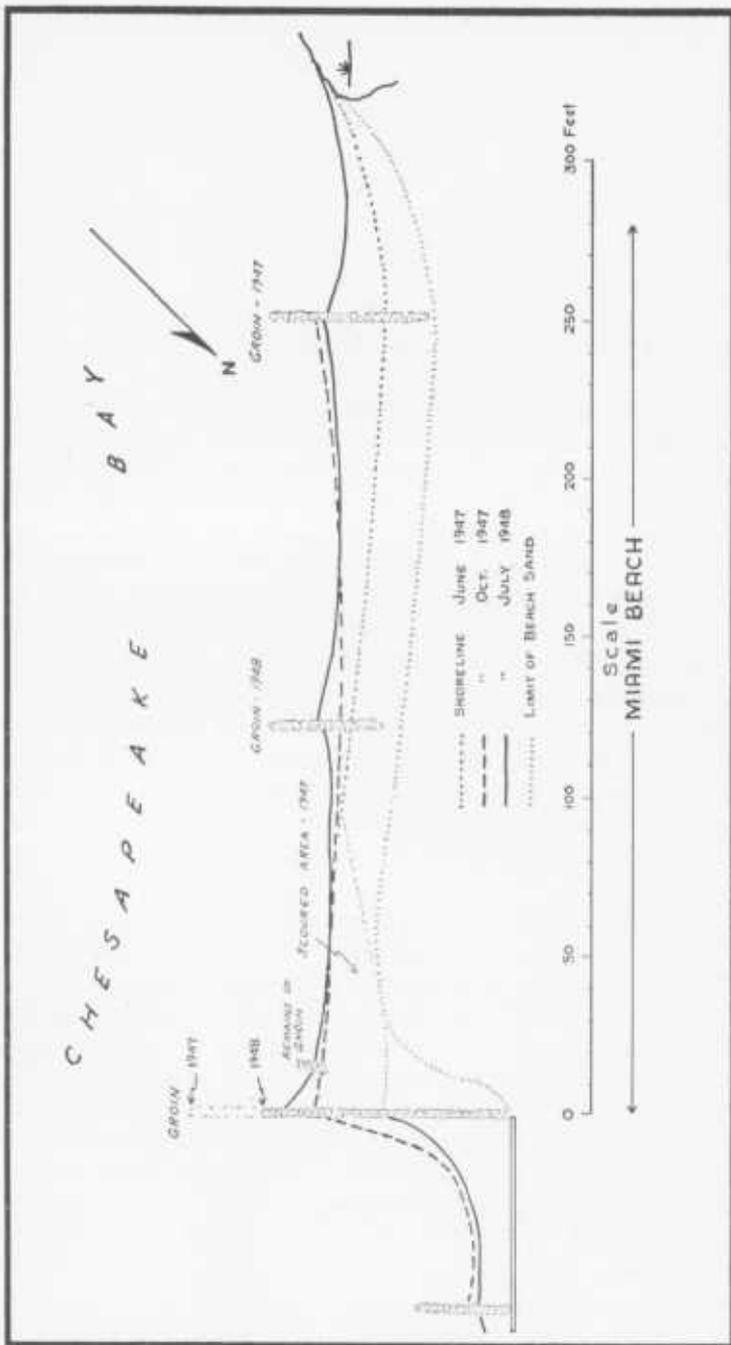
FIG. 1—Sketch of Miami Beach, Baltimore County, Showing Shore Line Changes and Protective Works.

This was a relatively stable beach with a loose-stone groin at the north end. In an attempt to widen the beach, two loose-stone groins were built in July, 1947, a long groin at the north end, where the beach on the north side of the old groin was 3 feet lower than on the south side, and a short groin at the south end. Erosion set in immediately on the south side of the long groin, scouring out the area shown on Figure 1 by September. The south half of the beach had widened appreciably on each side of the short groin.

Investigation of the situation indicated that the beach is a relatively "starved" beach, that the long groin had caused a rotary movement of the water which scoured the angle between the groin and the beach line, and that a "pumping" effect was filtering sand through the loose-stone groin to the lower level beach on the north side of the groin. It was recommended that the long groin be shortened and made impermeable to the passage of water through it, a third groin be built between the two groins, and the denuded area be replenished with coarse sand.

In May, 1948, the long groin was shortened 25 feet, the interstices between the stones were filled with cement, and sand was dumped on the scoured area to replace that which had been eroded. By July, 1948, all of the groins had collected sand. The scouring action at the north groin had been remedied.

Some erosion occurred again during a storm in the spring of 1949, beach sand being carried southward to the marsh beyond the beach. This sand movement was due in part to bad condition of the landward end of the south groin.

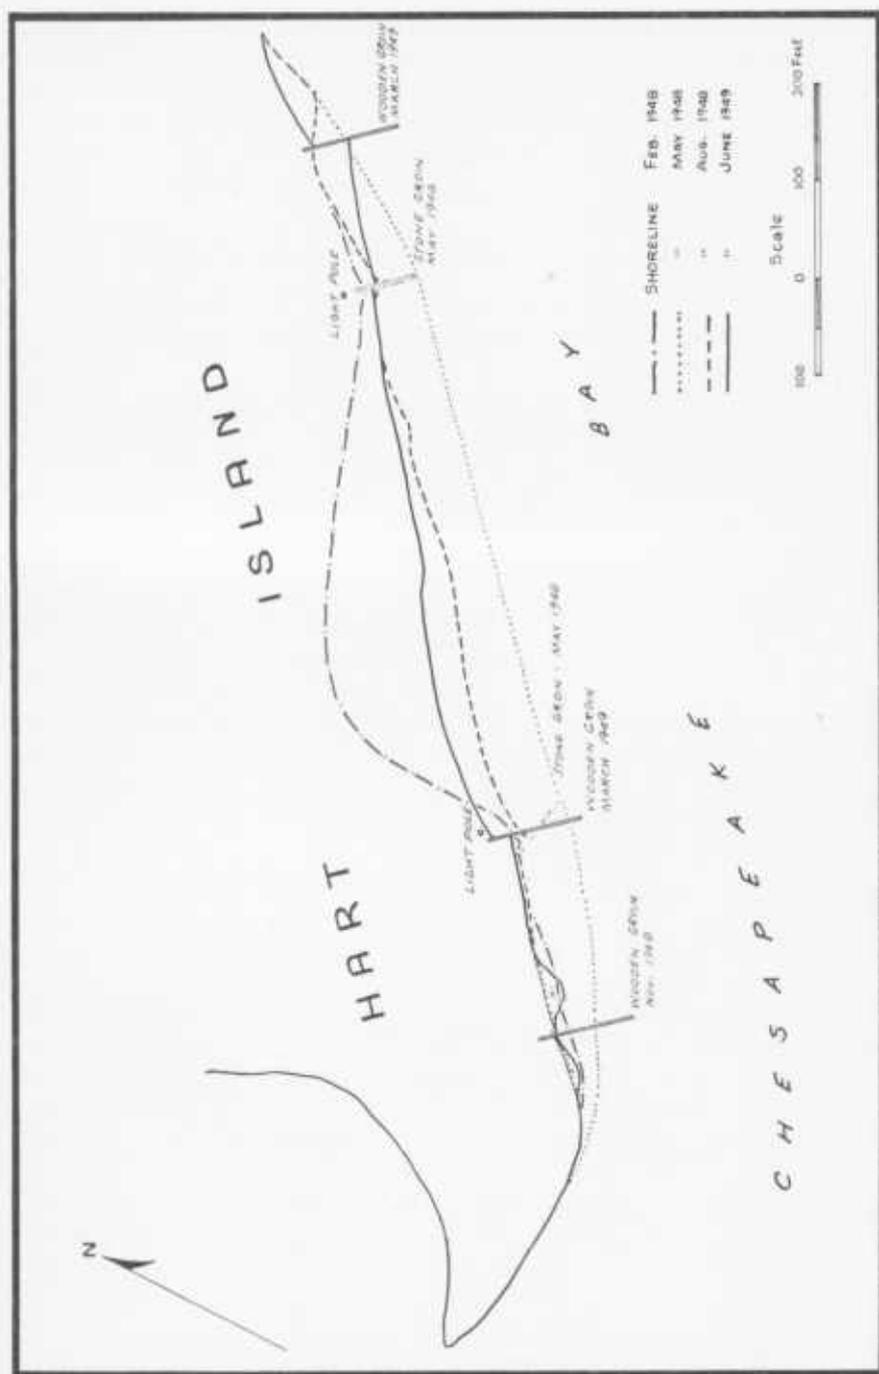
Fig. 2—Shore Line Changes at New Bay Shore Park, Hart Island, Baltimore County.

On inspecting the beach in August, 1948, the owners were advised that the fill used was smaller in grain size than the natural beach sand, the loose-stone groins were permitting sand to pass through them instead of accumulating it, the south groin should have been at right angles to the beach, and the distance between the groins was greatly in excess of effective spacing. The owners were advised further that more information regarding the erosion processes acting against this shore front was needed to plan effective erosion protection. It was recommended that two impermeable groins be built on the natural beach a short distance north of the Park beach and their effect on sand movement be observed through the weather cycle of one year. This would show the extent to which groins can hold the natural beach sands, and whether the beach receives enough long-shore moving sand to maintain a stable beach or even enlarge the beach by accretion, or whether it is a "starved" beach that will require additions of sand from time to time to maintain its width. It was also pointed out that additions of sand must be at least as coarse as the natural beach sands.

The recommended experimental work was not done. Instead, in the fall of 1948, one wooden groin was built at the south end of the Park beach and in the spring of 1949, two more wooden groins were built on that beach. In June, 1949, the area between the two southern wooden groins had undergone little change. In the area between the much too widely spaced groins to the north, recession of the beach continued and amounted to about 40 feet between August, 1948, and June, 1949.

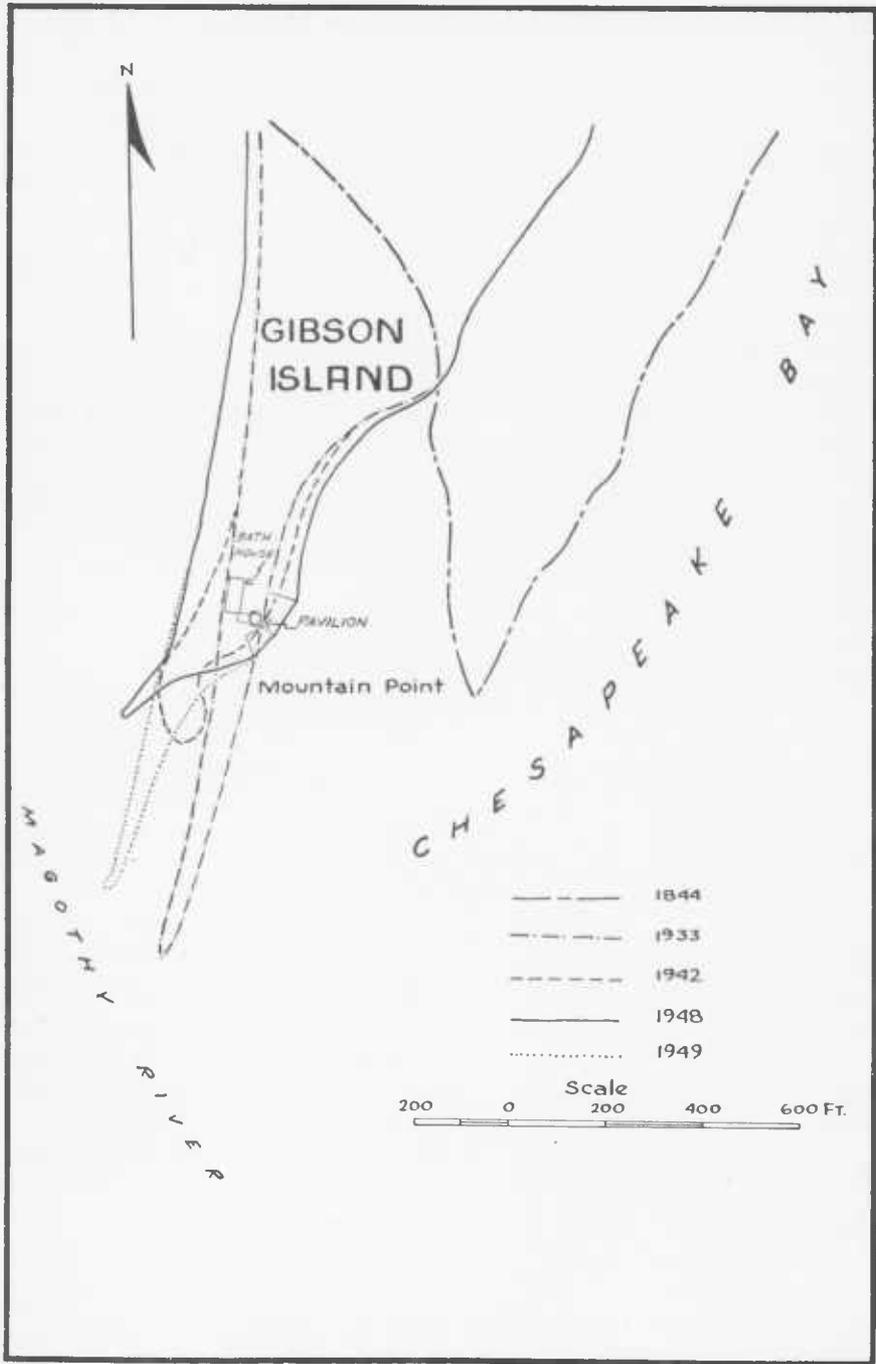
FIG. 3—Shore Line Changes at the South End of Gibson Island, Anne Arundel County.

Between 1933 and 1942, the Point receded more than 200 feet northward and migrated 80 feet further west, and had widened in places as much as 40 to 60 feet, most of the widening due to continued accretion on the Magothy River front. The change that began in 1933 was caused by the construction of many small groins and bulkheads along the east shore of the island north of Mountain Point which reduced the amount of source material reaching the Point. The Point became a "starved" area and erosion exceeded deposition.

Further change had occurred in 1948. The Chesapeake Bay front had built out from 20 feet to 30 feet since 1942, and substantial accretion had continued on the Magothy River front. The Point itself, however, had receded 60 feet further northward and had migrated 120 feet further west, and had narrowed greatly. This change is ascribed to the construction of three loose-stone groins on the Chesapeake Bay front to protect the pavilion. These groins further starved the tip of the Point, so that erosion continued there, by holding source material from the north and building out the Chesapeake Bay front north of the tip.

Another examination in July, 1949, found that since September, 1948, accretion had again set in at the tip and that the Point had extended more than 370 feet southward, making it nearly as long as in 1933, but had migrated 140 feet further to the west. Two factors contributed to this change, lack of severe storms during the preceding winter and spring, and an increase of source ma-

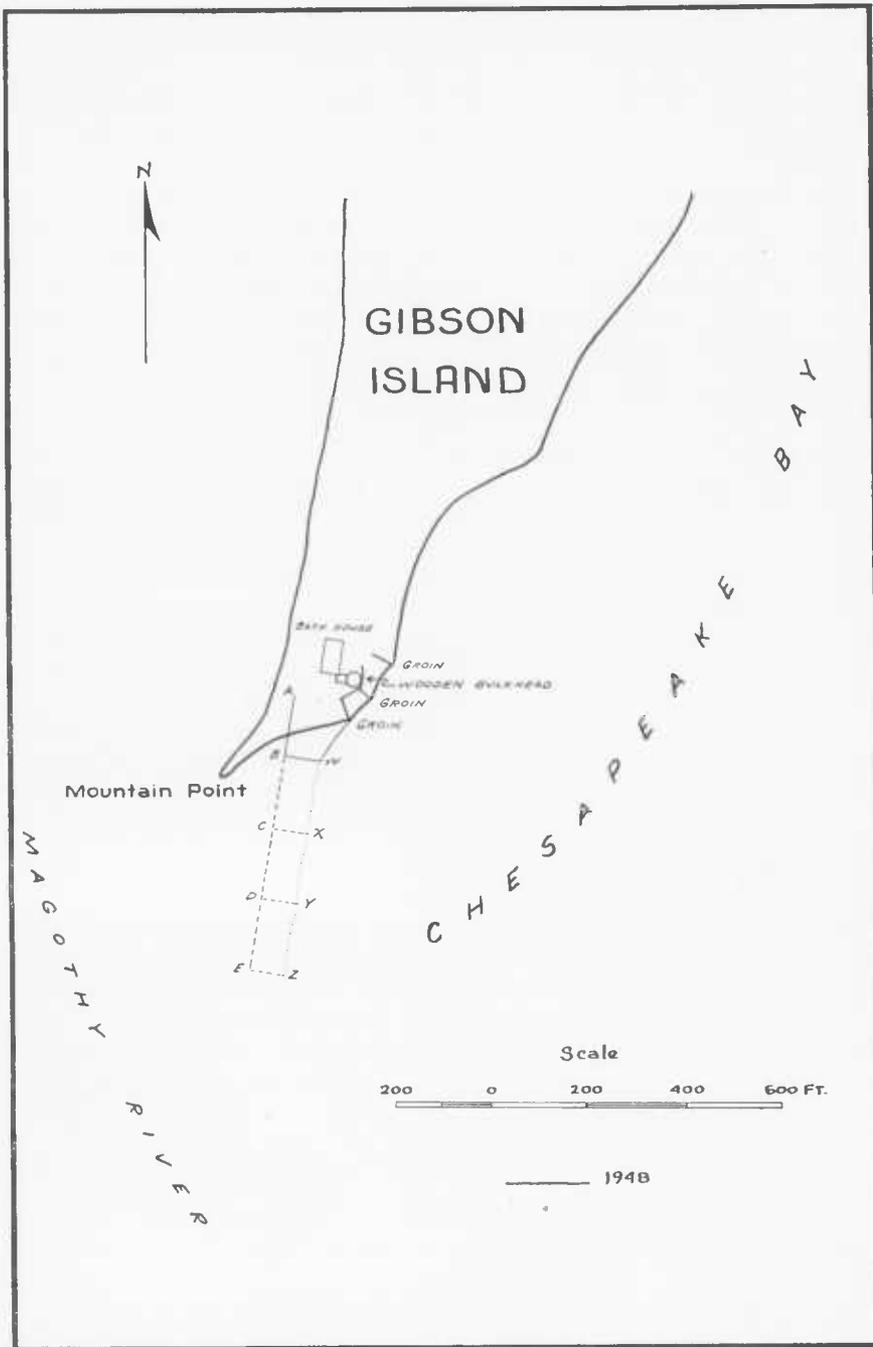
FIG. 4—Recommended Bulkheads and Groins for the Stabilization of the Southern End of Gibson Island, Anne Arundel County.

The vicissitudes of Mountain Point have been a source of concern and inconvenience in its use as a recreational area. Plans for the stabilization of the Point recommended in 1948 are shown in Figure 4. It was recommended that a bulkhead be built in stages along the line AE and that a groin BW be built at the end of the bulkhead at each stage, the stages to follow each other as the area in front of each section of the bulkhead and north of the groin had filled with sand. Overflow from the groin and storm and wind transported sand across the bulkhead will accumulate in the persistent area of deposition on the Magothy River side of the bulkhead. In this way the Point can be stabilized on the Chesapeake Bay side and be increased in width on the Magothy River side.

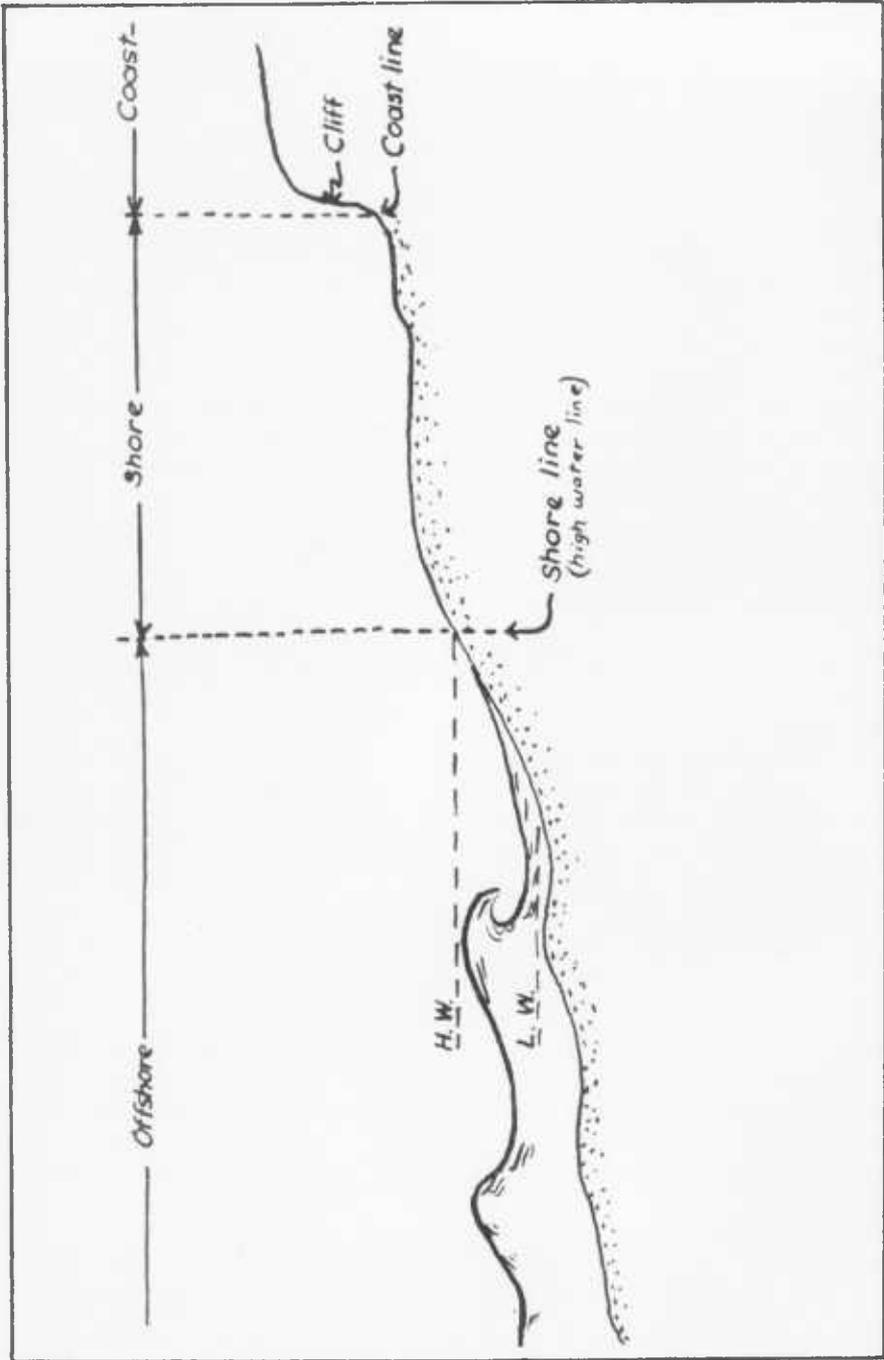
FIG. 5—Illustration of Technical Terms.

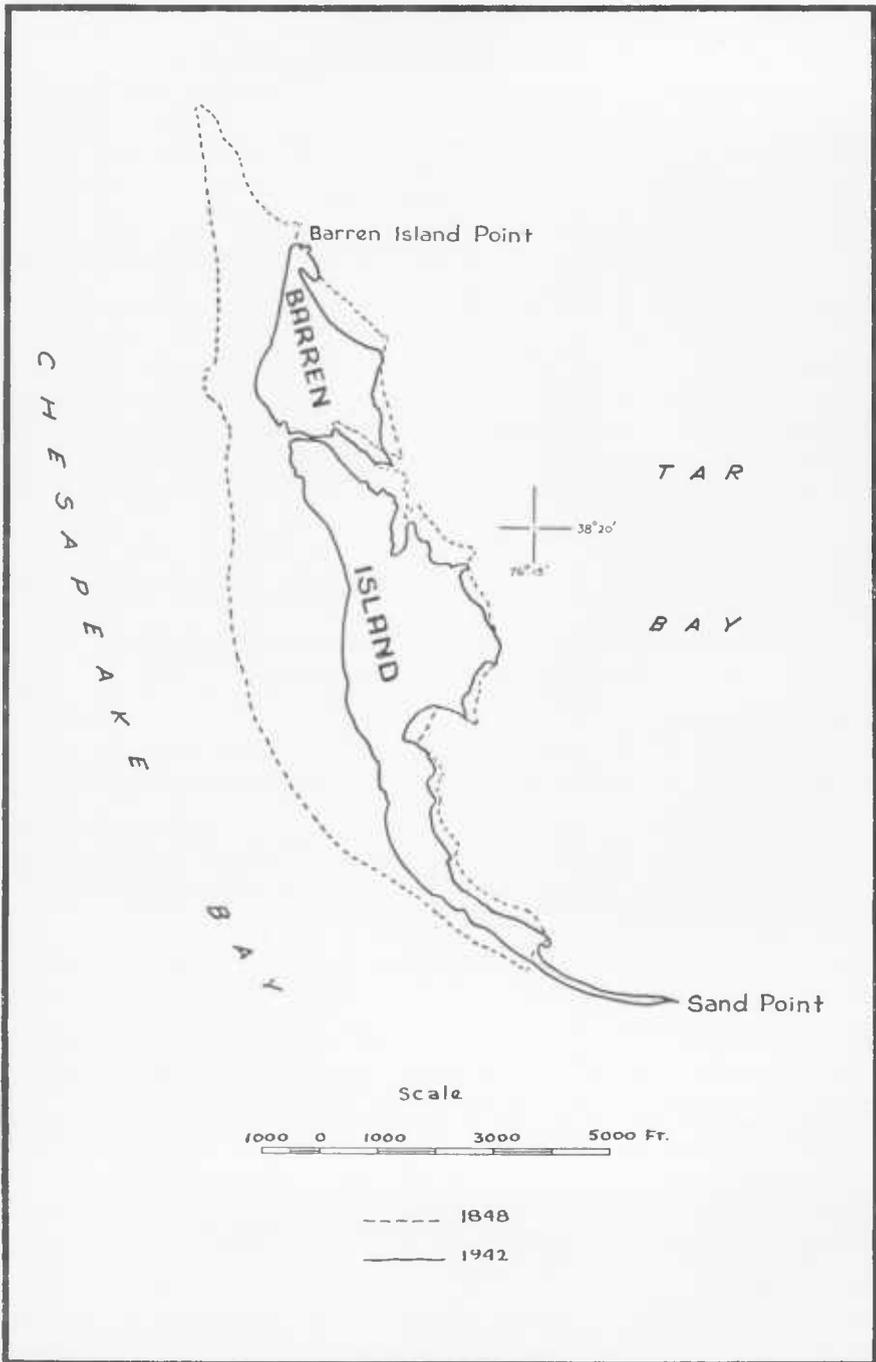
FIG. 6—Shore Line Changes on Barren Island, Dorchester County.

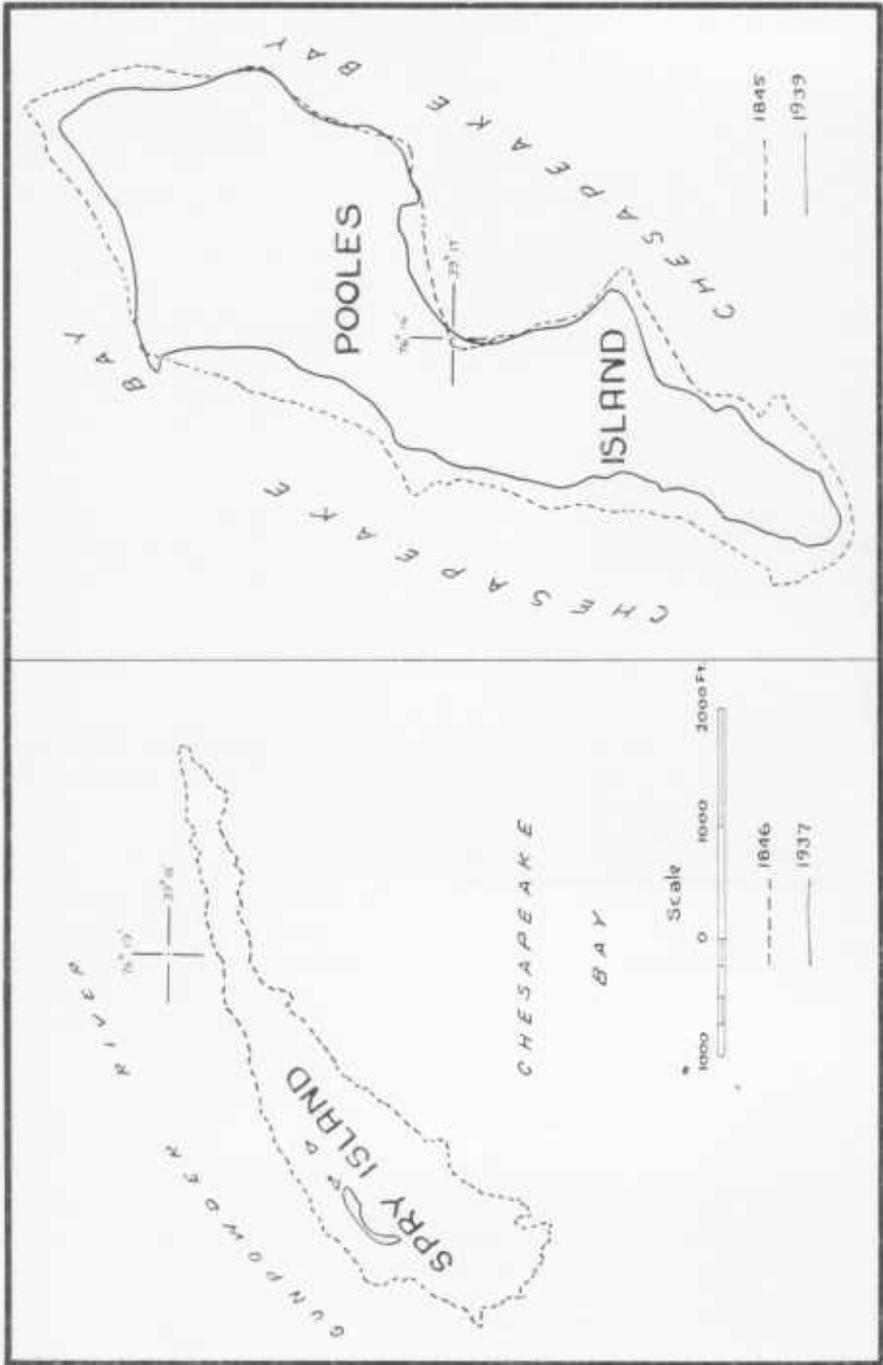
FIG. 7.—Shore Line Changes on Pooles Island and Spry Island, Harford County.

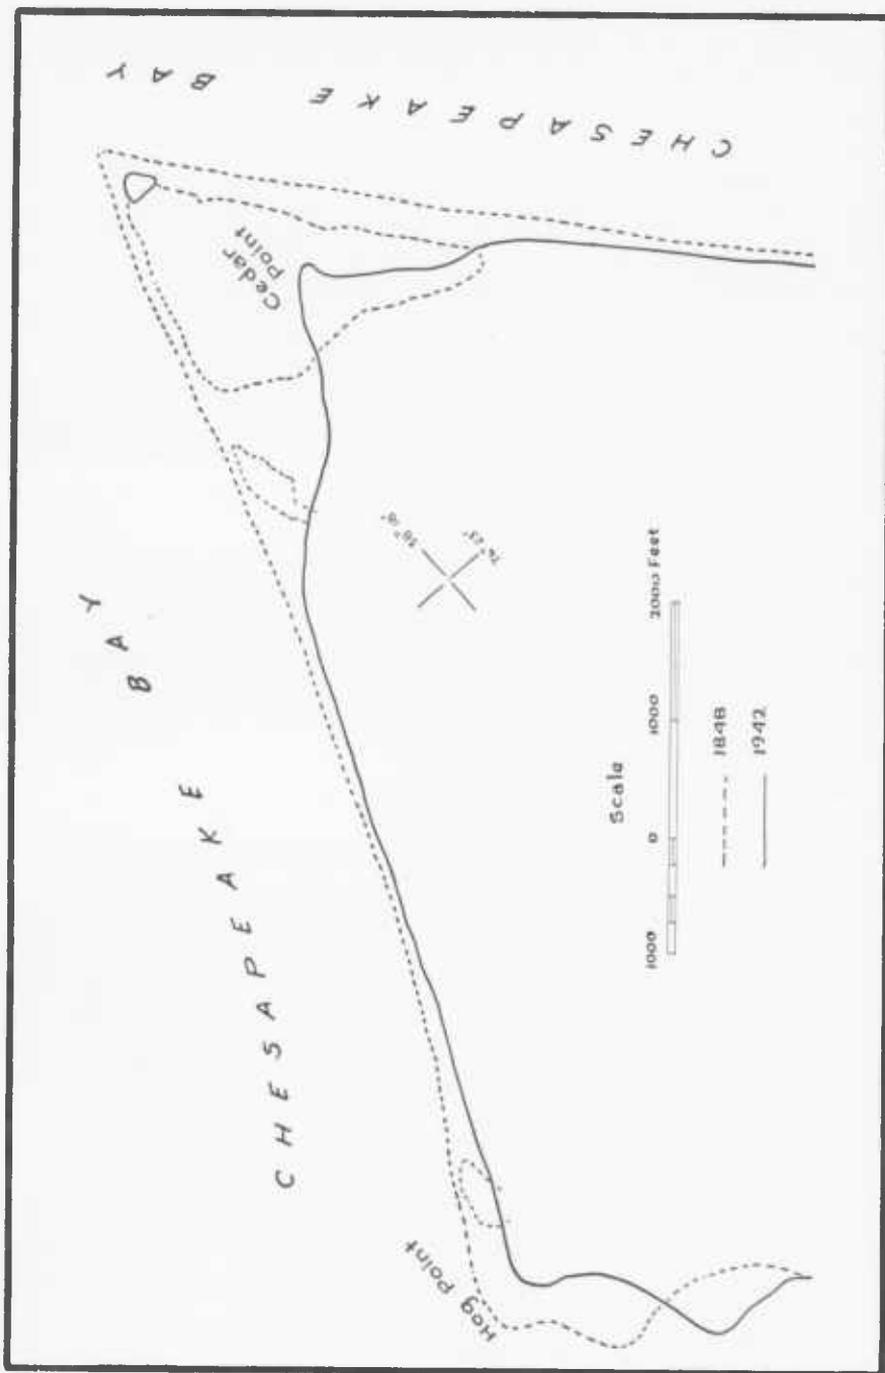
FIG. 8—Shore Line Changes in Cedar Point Area, St. Marys County.

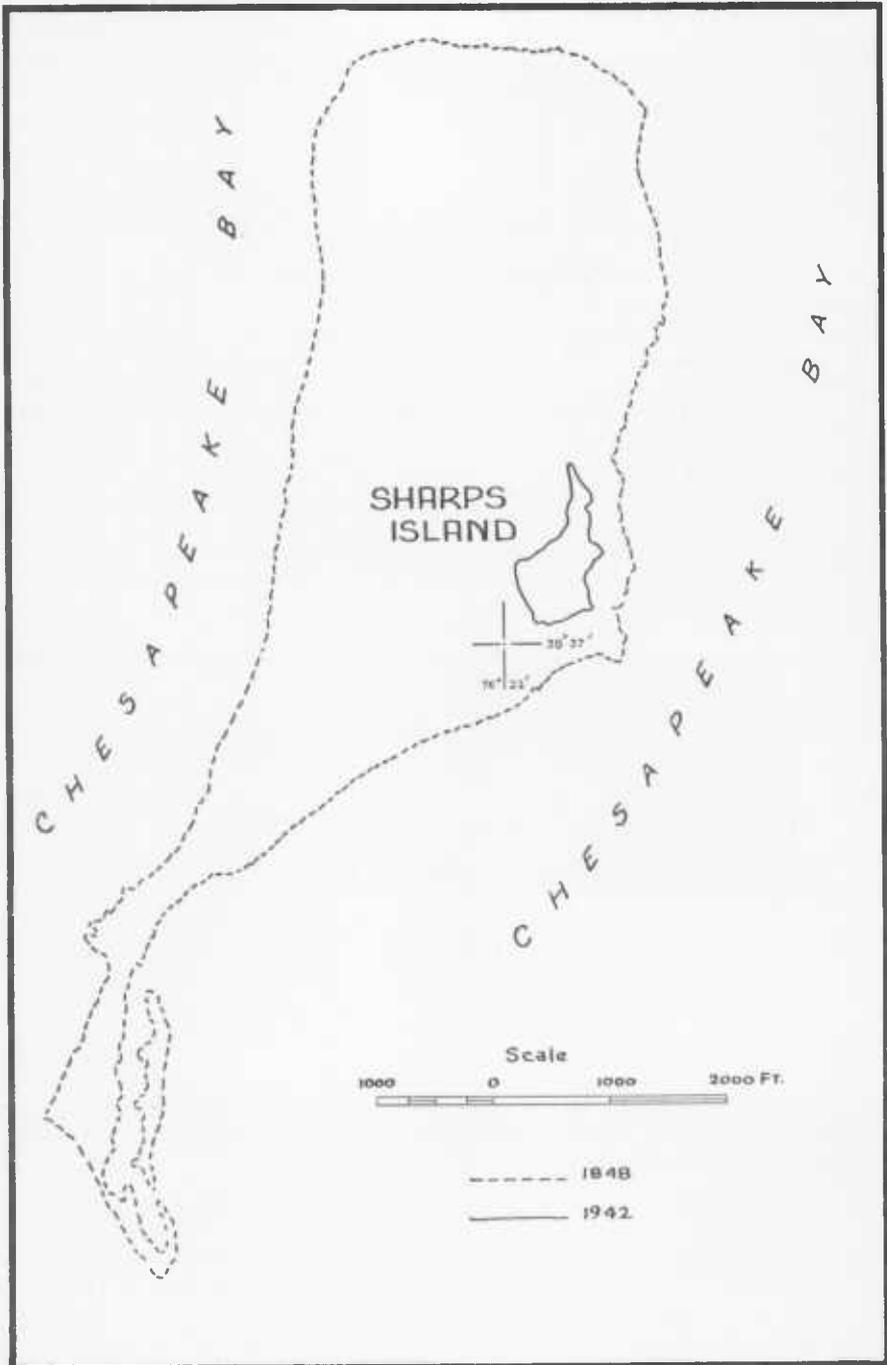
FIG. 9—Shore Line Changes on Sharps Island, Talbot County.

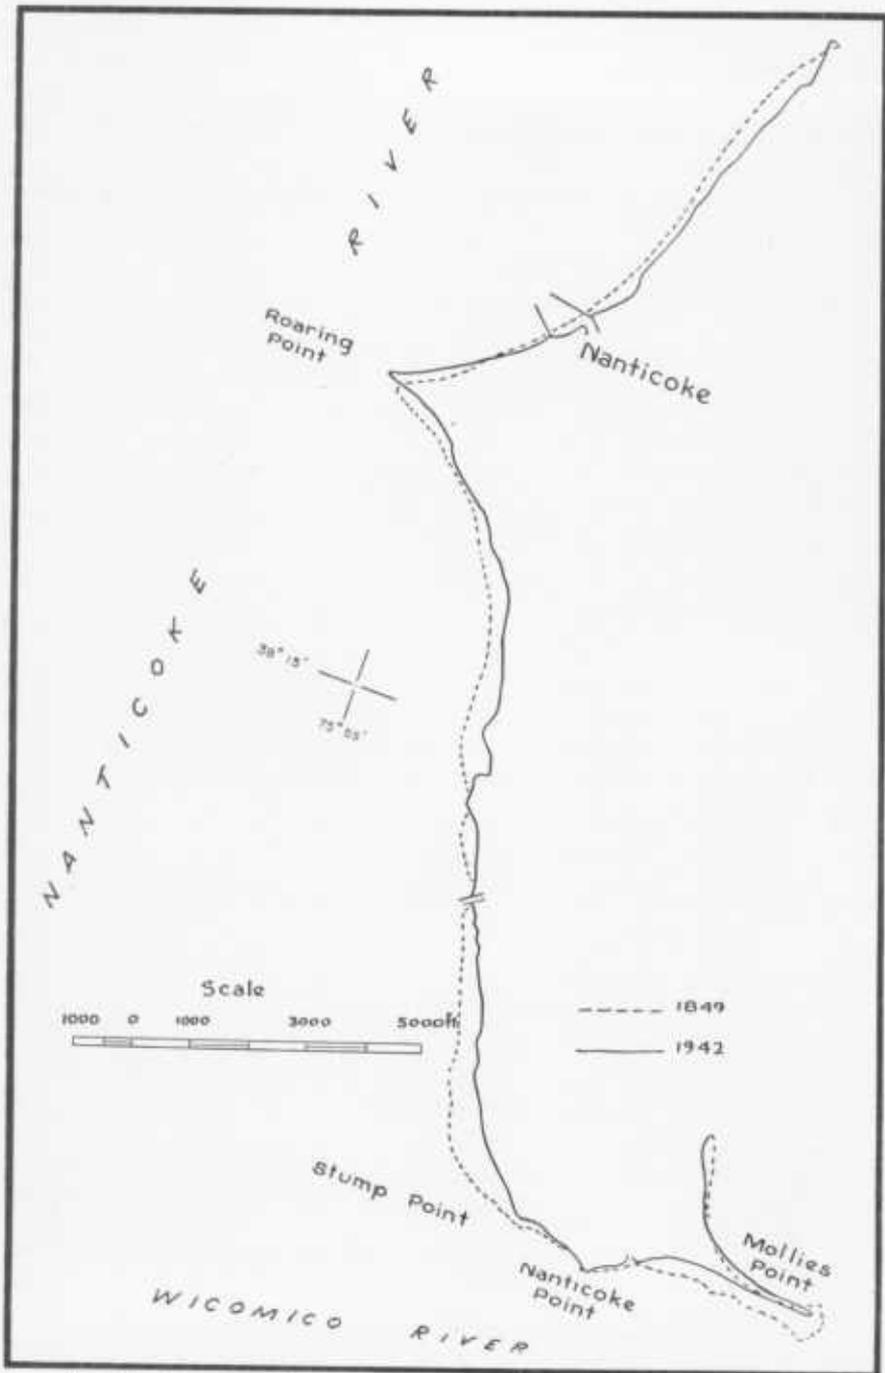
FIG. 10—Shore Line Changes from Mollies Point to Nanticoke, Wicomico County.

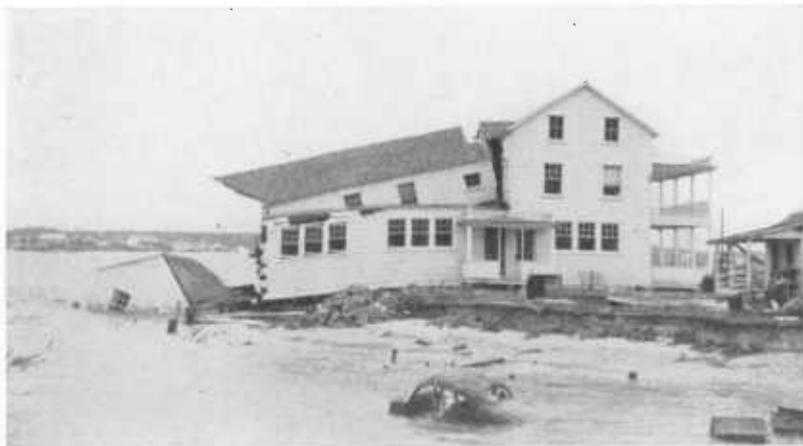
PLATE 29, FIG. 1

Location: East end of North Harbor Road facing south on Sinepuxent Bay, Ocean City, Worcester County.

Remarks: Due to a shift in position of the large sand spit at the west end of the southern side of Ocean City inlet which changed current direction and velocity, the shore line at this point suddenly began to erode with the subsequent total destruction of the house at that location.

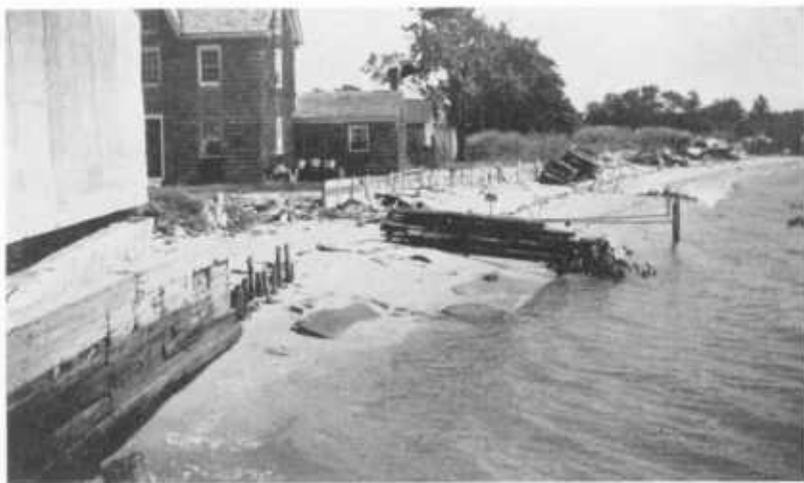
PLATE 29, FIG. 2

Location: The northwest shore of Deal Island facing Tangier Sound, Somerset County.

Remarks: Wave and storm tides have eroded this unprotected, low, sandy portion of the island at the rate of 2 to 3 ft. per year, necessitating immediate protection or movement of the house. Mute evidence of the site of former solid ground is the water pipe in the water on the right.

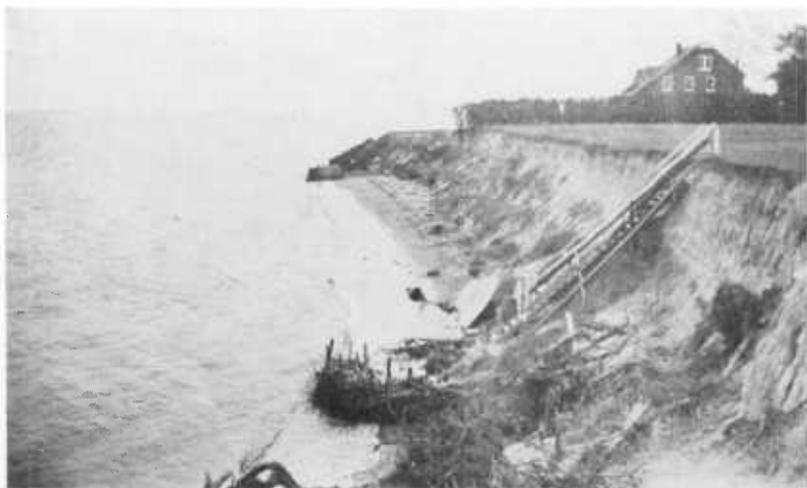
PLATE 30 FIG. 1

Location: Log Inn, south of Tydings on the Bay, Anne Arundel County.

Remarks: In 1930-31 a concrete bulkhead was constructed in front of the house and one 400 ft. to the north in front of another building. Since that time the shore front between the bulkheads has receded a maximum of 100 ft. or an average of 5 ft. per year.

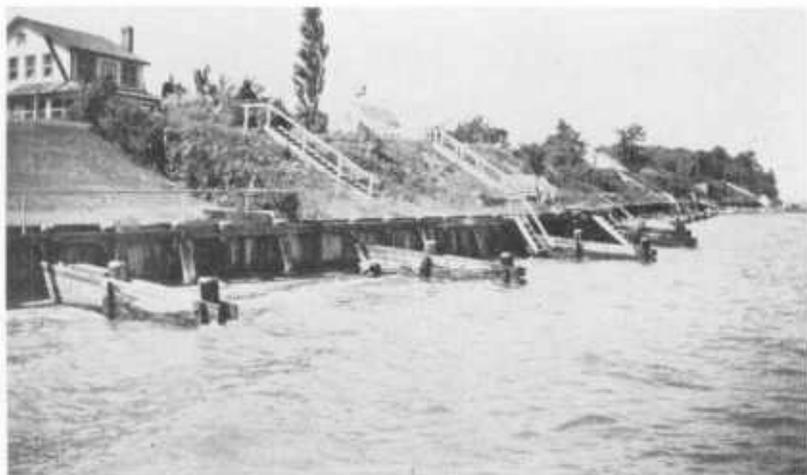
PLATE 30 FIG. 2

Location: Tydings on the Bay, Anne Arundel County.

Remarks: The bulkhead was constructed in 1936 and is still in excellent condition.

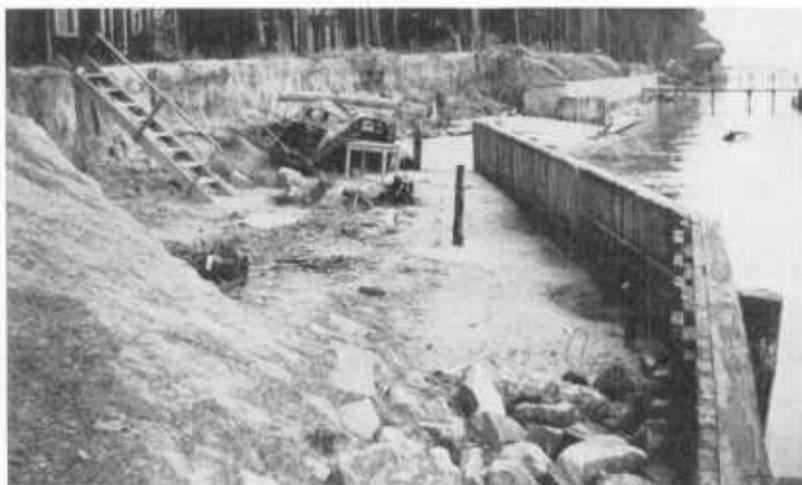
PLATE 31, FIG. 1

Location: Tall Timbers on the Potomac River, St. Marys County.

Remarks: This shows the ineffectiveness of discontinuous bulkheads. Erosion of the unprotected areas between the bulkheads leads to the eventual destruction of the bulkheads, by eroding around their ends and undermining them from the rear.

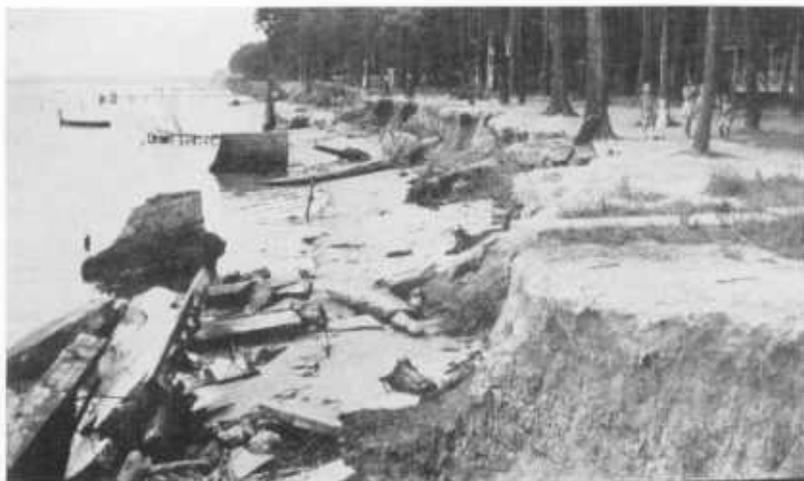
PLATE 31, FIG. 2

Location: Tall Timbers on the Potomac River, St. Marys County.

Remarks: The concrete buttresses are the remnants of a bulkhead built in 1931. The shore continued to recede after the destruction of the bulkhead.

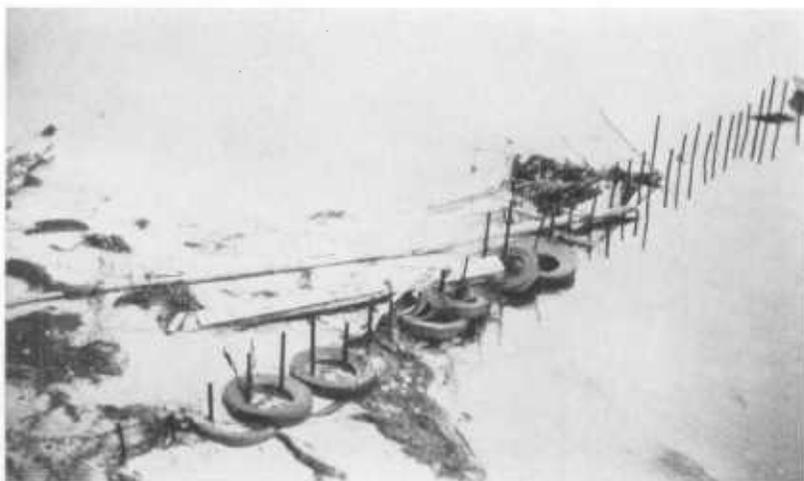
PLATE 32, FIG. 1

Location: Choptank River, Cambridge, Dorchester County.

Remarks: An improvised and inexpensive groin made of old tire casings thrown over iron pipe driven into the bottom. Ample littoral drift supply and not too severe wave and current action permit a degree of effectiveness.

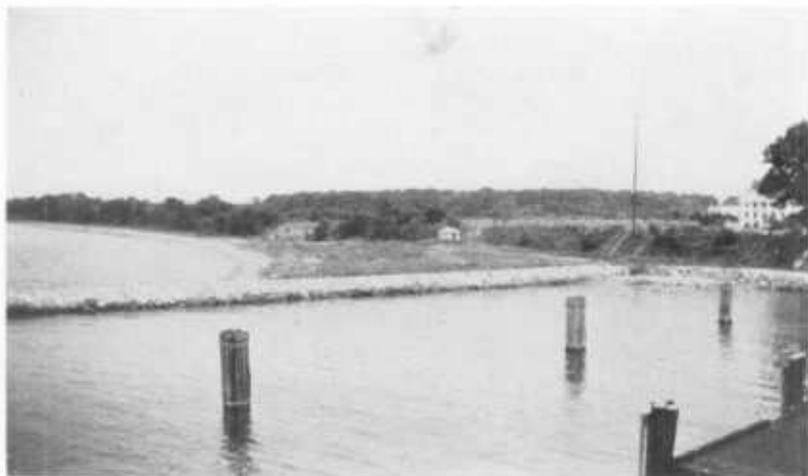
PLATE 32, FIG. 2

Location: Northern groin at Matapeake Ferry Landing, Queen Annes County.

Remarks: In 19 years a predominant southerly-moving littoral drift has accumulated to form a wide beach on the north side of the groin.

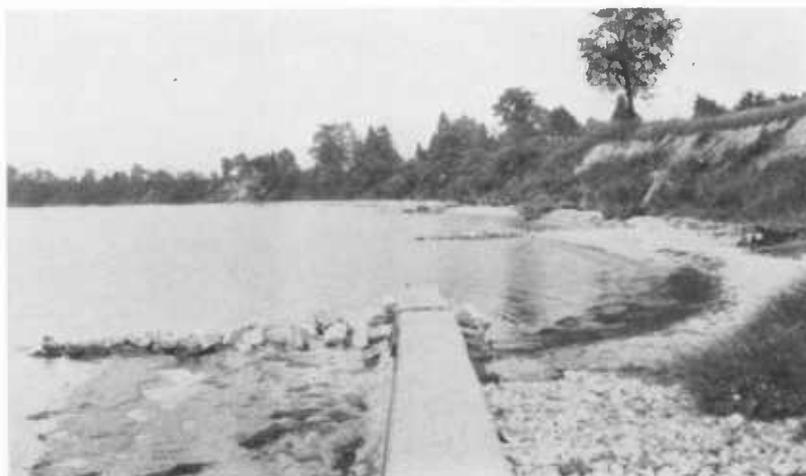
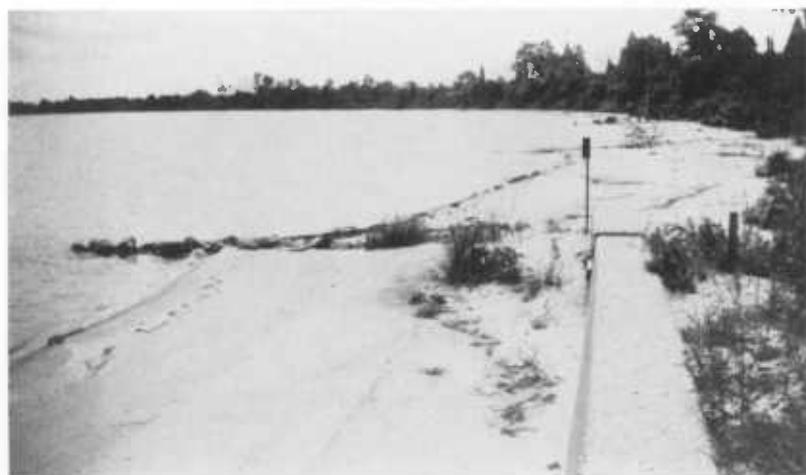
PLATE 33, FIGS. 1 AND 2

Remarks: Small rubble groins have accumulated enough additional beach in 6 months to protect the end of the concrete wall that was being undermined by erosion. Wave and current action are not severe and the littoral drift supply abundant.

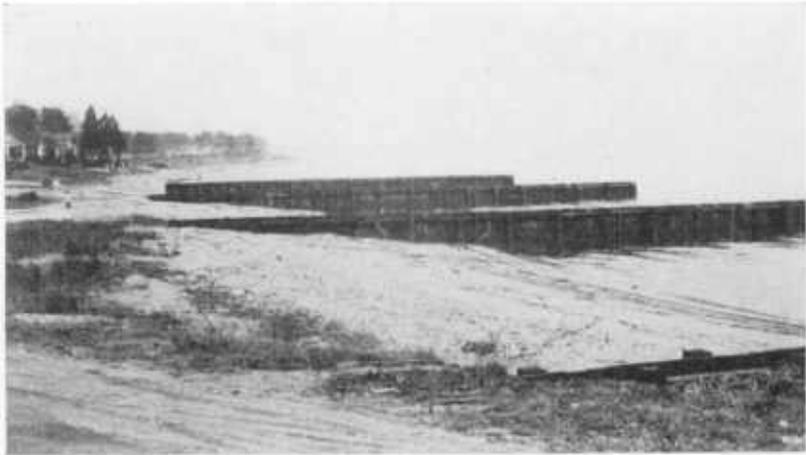
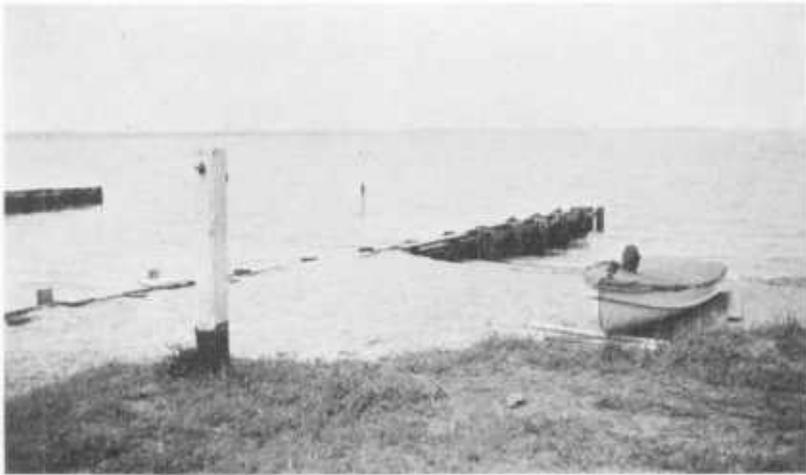
PLATE 34, FIGS. 1 AND 2

Remarks: Illustrate the effectiveness of a groin to hold and to build out a beach when there is sufficient littoral drift supply.

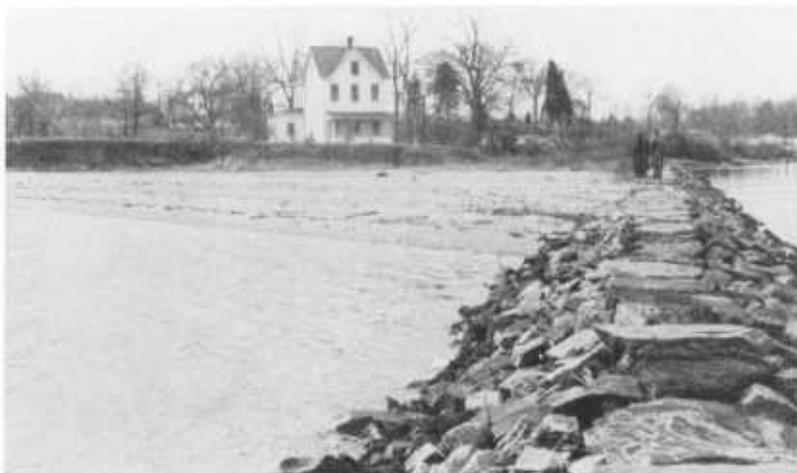
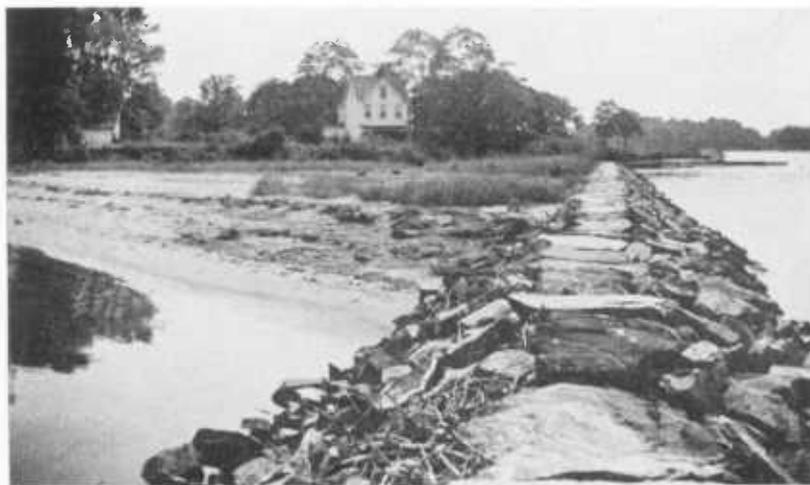
PLATE 35, FIGS. 1 AND 2

Remarks: Over a relatively short period a considerable amount of littoral drift has accumulated on the southeast side of the stone jetty, evidencing an ample supply of sand moving along the beach at this point.

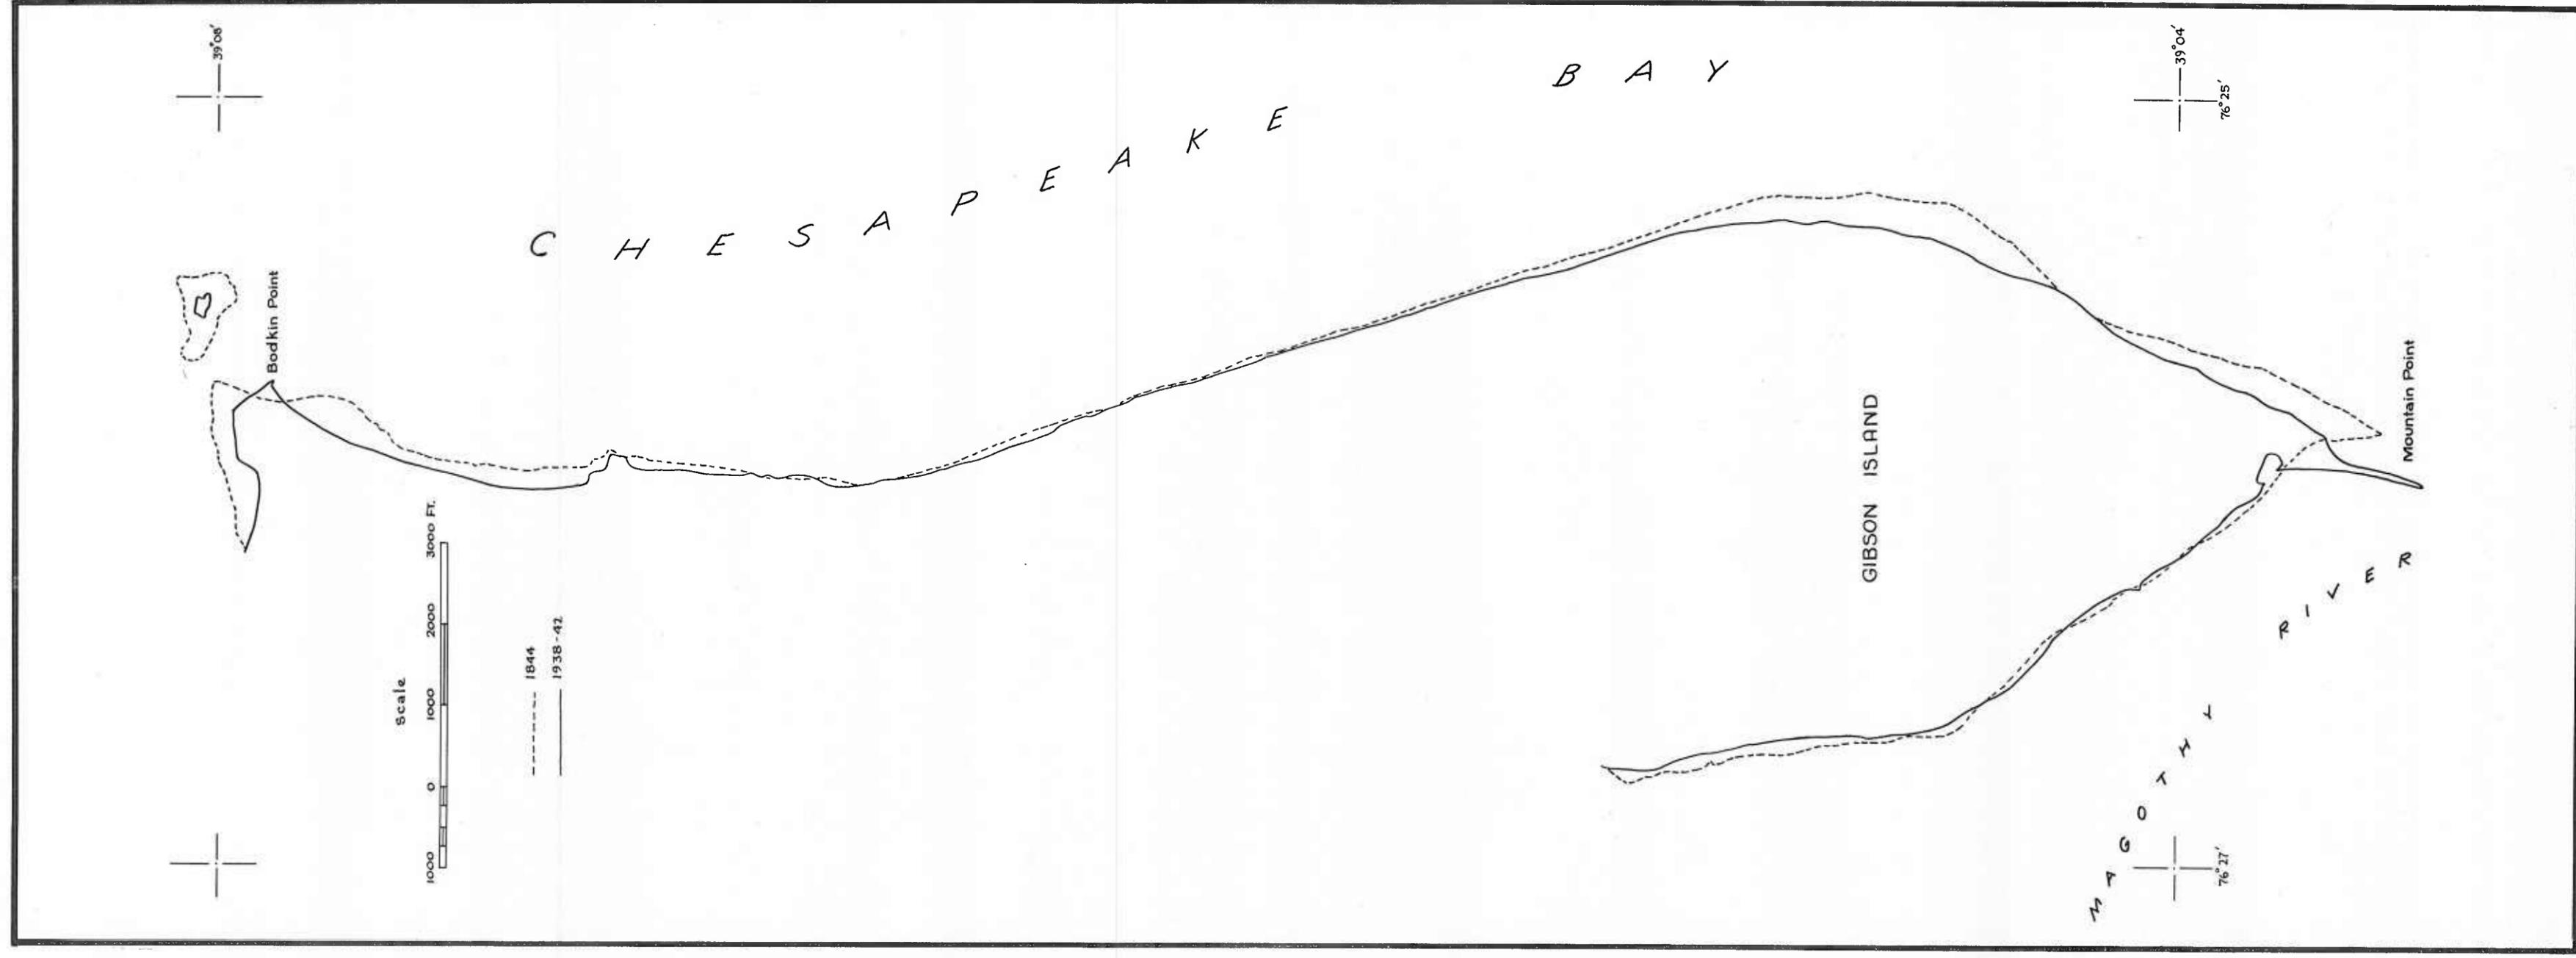
PLATE 1. Shore Line Changes from Bodkin Point to Mountain Point, Anne Arundel County
